MORNING-GLORY SHAFT SPILLWAYS:  
PERFORMANCE TESTS ON PROTOTYPE  
AND MODEL

by A. J. Peterka, A.M. ASCE

HYDRAULICS DIVISION

## MORNING-GLORY SHAFT SPILLWAYS: PERFORMANCE TESTS ON PROTOTYPE AND MODEL

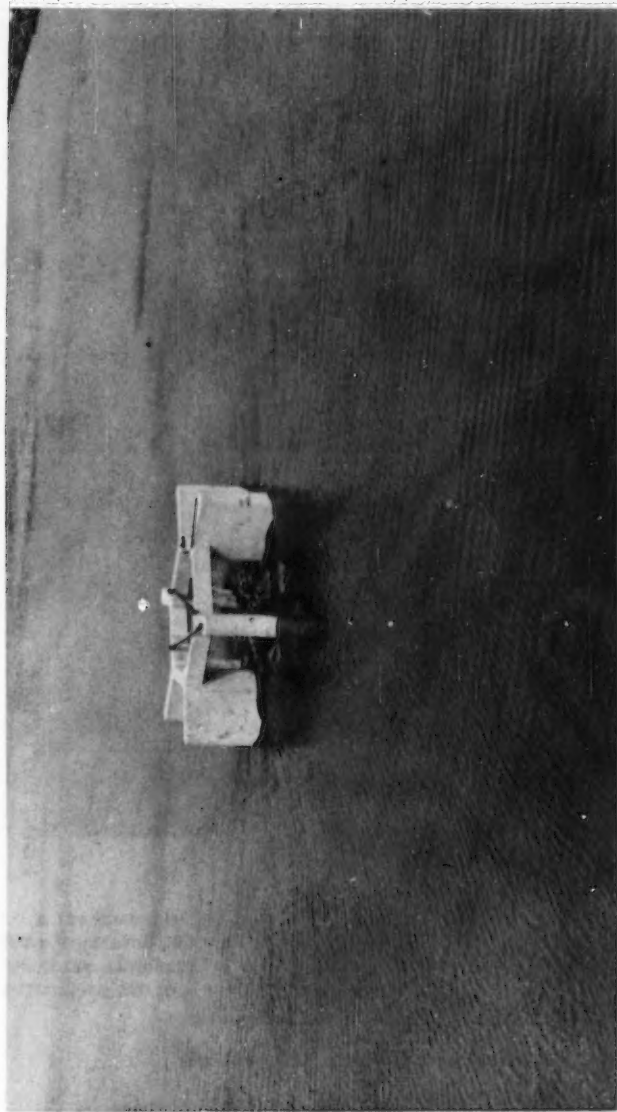
Fig. 18

On April 28, the reservoir was down to elevation 2071, or about 0.7 foot above the point where the flow changes from submerged to free discharge, see Figures 18 and 12. The photograph indicates the mild condition inside the spillway. There was no pulsation or rising and falling of the "mushroom."

On April 28, 1950, the reservoir was at elevation 2071, or about 0.7 foot above the point where the flow changes from free to submerged. Action inside the morning-glory is very mild. Note flow lines visible on water surface.

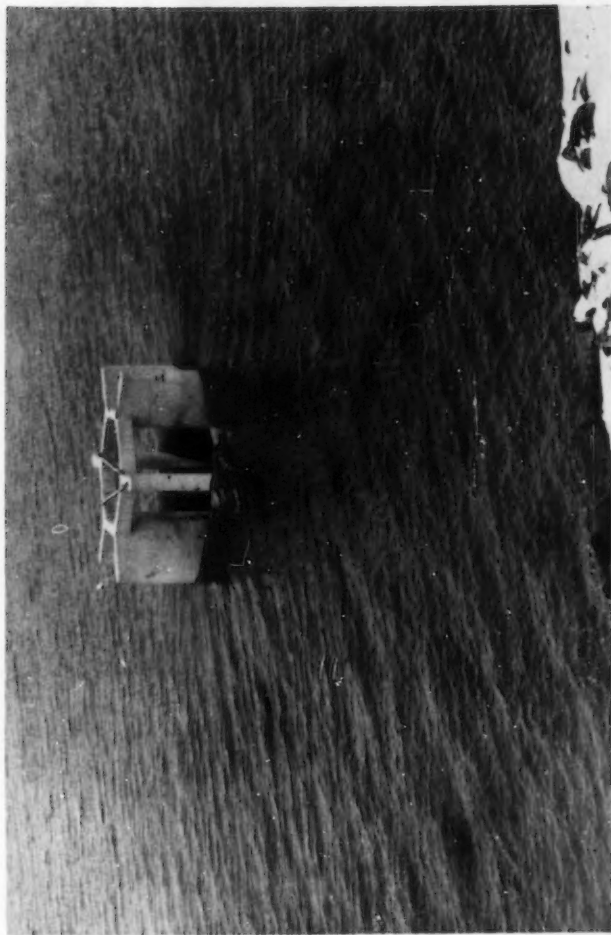
Fig. 19

On April 30, the spillway was discharging freely (1,600 cfs) with reservoir elevation 2068.6, see Figure 19. No spray emerged from the glory hole at this or lower heads as has been noted on some other glory hole spillways.

The spillway was discharging freely on April 30, 1950, with reservoir elevation 2068.6.  
HEART BUTTE DAM - Spillway Operation—Discharge 1,600 cfs

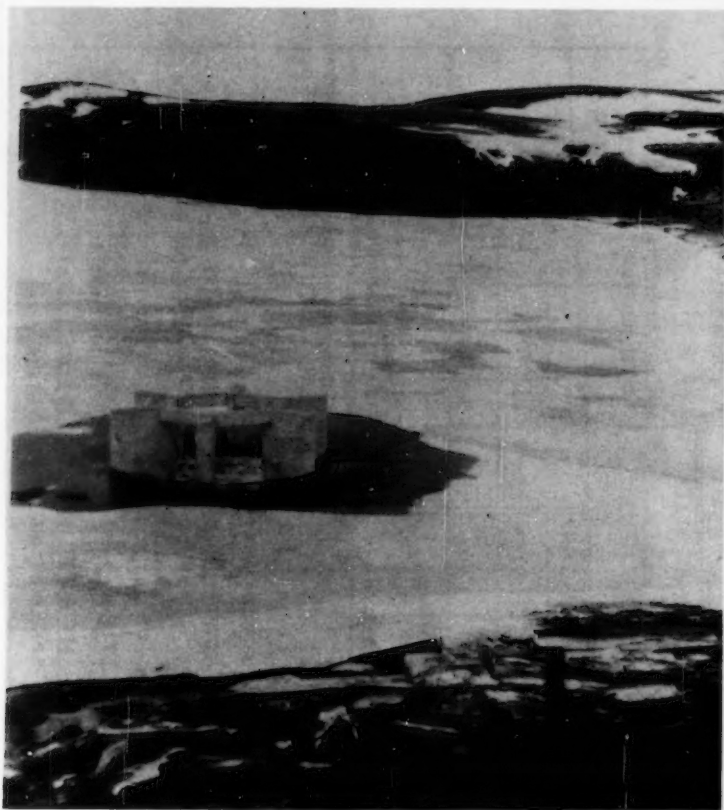
**Fig. 20**

One year later the spillway again went into operation, reaching a maximum reservoir elevation of 2075, or about 7 feet less than occurred in 1950. On March 27, 1951, the reservoir was at elevation 2070, see Figure 20, about 0.2 foot below the submergence point. Again the operation was satisfactory with no visible difficulty despite the fact that on February 15, 1951, the ice in the reservoir was 36 inches thick. There was no difficulty due to ice.

In the Spring of 1951 the reservoir rose to elevation 2075.0. This photo, taken on March 27, shows the reservoir at elevation 2070.0, or about 0.2 foot below the submergence point. In February the ice was 36 inches thick but no difficulties due to ice were encountered.

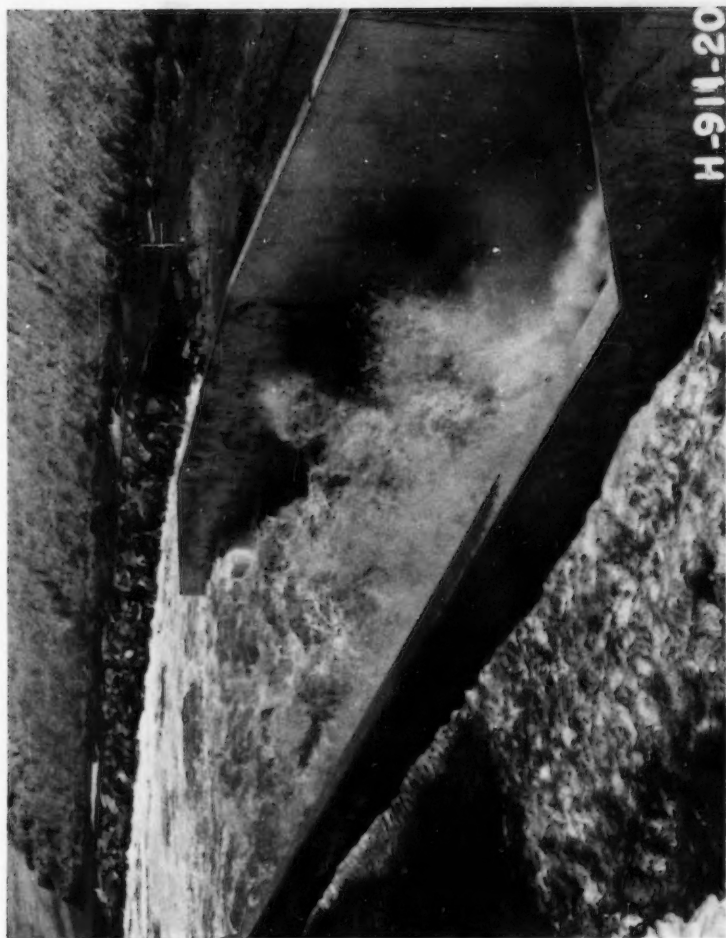
Fig. 24

The profile of the hydraulic jump is indicated along the stilling basin wall. Flow leaving the basin is smooth and uniform.

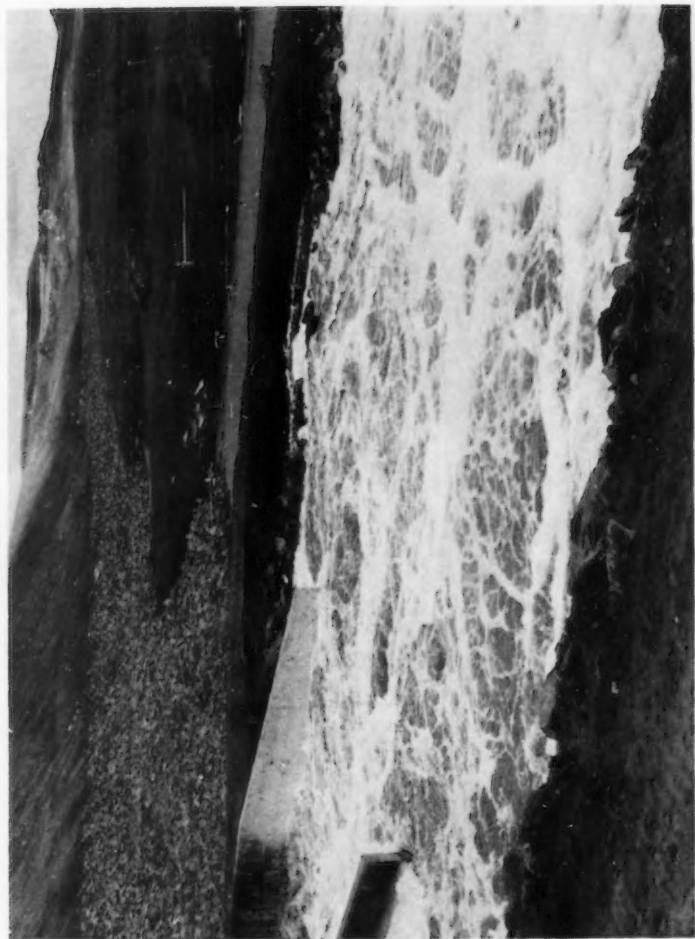
Fig. 25

Flow leaving the basin had no choppy waves but did have mild swells and boils.

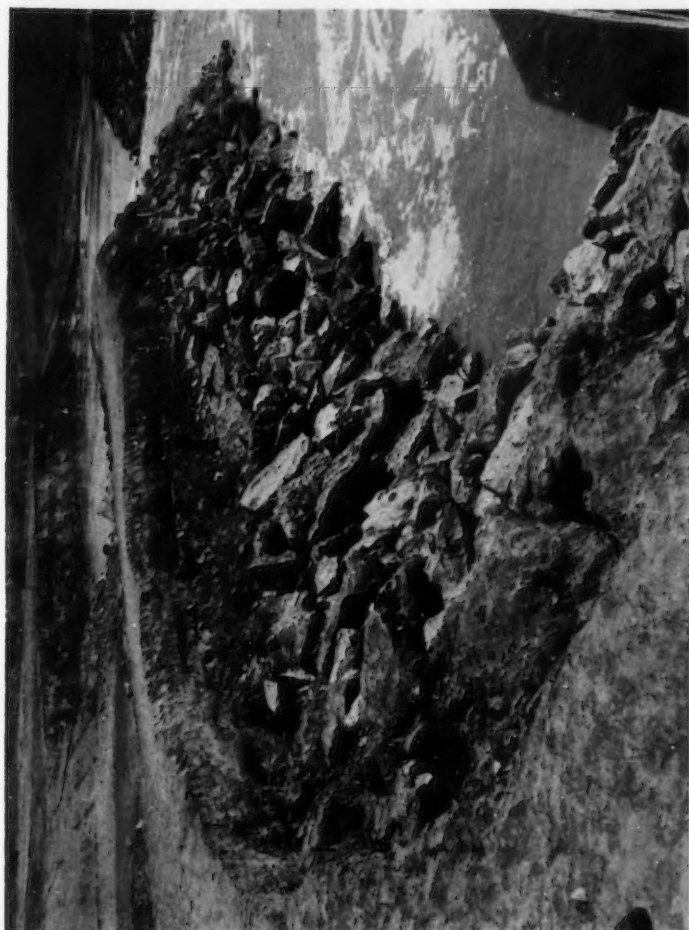
Fig. 30

Conversely, the channel banks, despite their riprap cover, were eroded to a greater degree. The riprap, however, had been placed in a thin layer, was not well graded as to size, and in places the earth banks could be seen between the individual rocks. Swells were observed to rise over local areas and penetrate very easily into the large voids. When the water receded some of the earth was removed from behind the riprap. This was evidenced by the darker, earth-colored water which could be seen adjacent to the riprap. After several days of operation the riprap had slumped and the earth banks had caved as shown in Figure 30. In spite of the apparent damage to the banks the riprap still continued to provide a good measure of protection against further cutting.

The bank damage was not caused primarily by waves of the ordinary variety, since these were only a matter of inches in over-all height, but rather by swells caused by surges in the hydraulic jump. The model stilling basin had been equipped with baffle piers and chute blocks to reduce the over-all length of the stilling basin and decrease its cost. It had been noted during these and other model tests that when a hydraulic jump is reduced in length by the use of artificial devices such as baffle piers that the jump becomes more stable in most respects, but does exhibit a tendency to produce the swells discussed above. The swells are considered the lesser of the evils, however, and are not impossible to cope with. With a base layer of gravel and successive layers of larger and larger rock there probably would have been no damage.

Loss of bank material was caused by swells removing fine material from behind the coarse riprap. Note man standing on the riprap.

Inspection of the riprap downstream from the stilling basin, following the 1950 flood, indicated that repairs would be advisable. The slumped riprap in the channel immediately downstream from the stilling basin structure was repaired in May and June 1950. Gravel backfill was placed on the slopes to bring them to grade and rock replaced over the gravel. The erosion of the riverbank just downstream from the end of the riprapped channel was sloped and covered with gravel and rock.

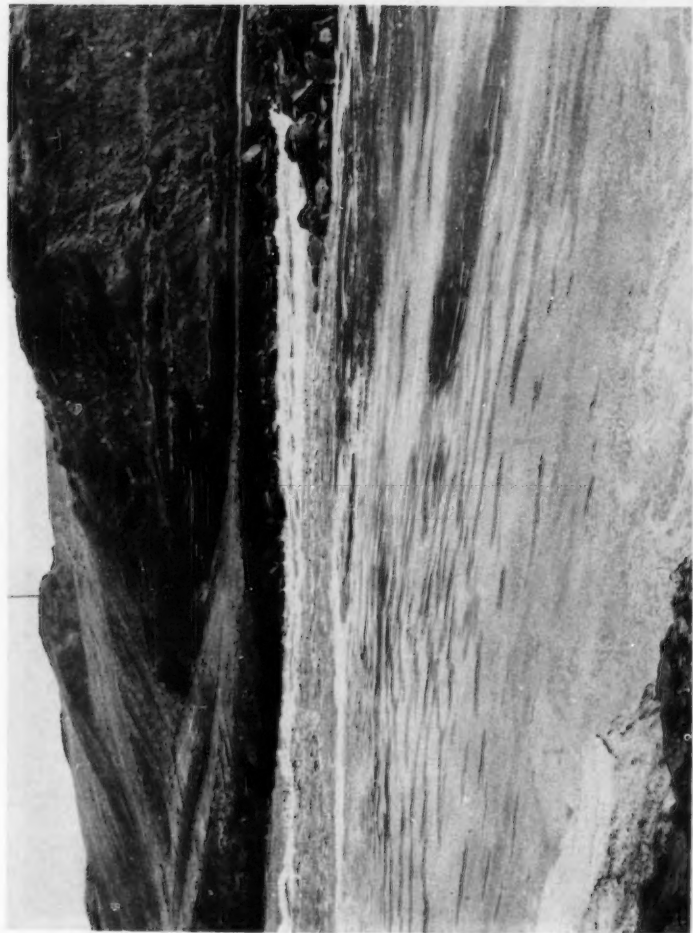
The difference in water levels between the excavated channel and the river was the cause of the high-velocity flow entering the Heart River. Water leaving the stilling basin was of relatively low velocity and would not have caused ill effects as it entered the river. The 4-foot difference in elevation, however, caused an increase in velocity which proved to be sufficient to cause considerable damage to the unprotected riverbank downstream. Some of the damage was caused by the direct effects of the current flowing diagonally across the river and cutting into the far or left bank. A great share of the damage, however, was caused by a large induced eddy in the river. This eddy caused an upstream current along the left bank which removed large volumes of material from areas considerably upstream from the point where the main flow impinged on the bank. Although the damage was considerable in extent, it had no ill effects on the structure or its operation. Riprap placed in the eroded area will prove of value, however, since the damage will become greater with each successive run-off and the end result is difficult to predict. The bank damage is illustrated in Figure 33. A comparison of Figures 23 and 34 shows the extent of the bank damage which occurred between the start of the run-off and May 5, 1950.

Flow entering the river from the excavated river channel was accelerated by the difference in elevation apparent in the photograph. At 3,700 cfs the difference was about 4 feet.

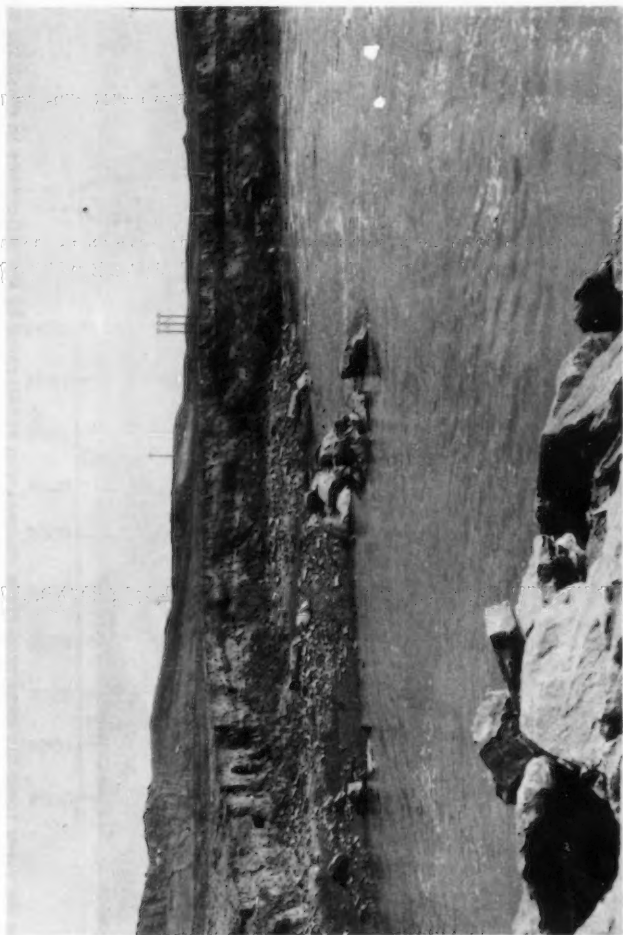
Fig. 33

After flood had receded the loss of bank material opposite the excavated channel was readily apparent.

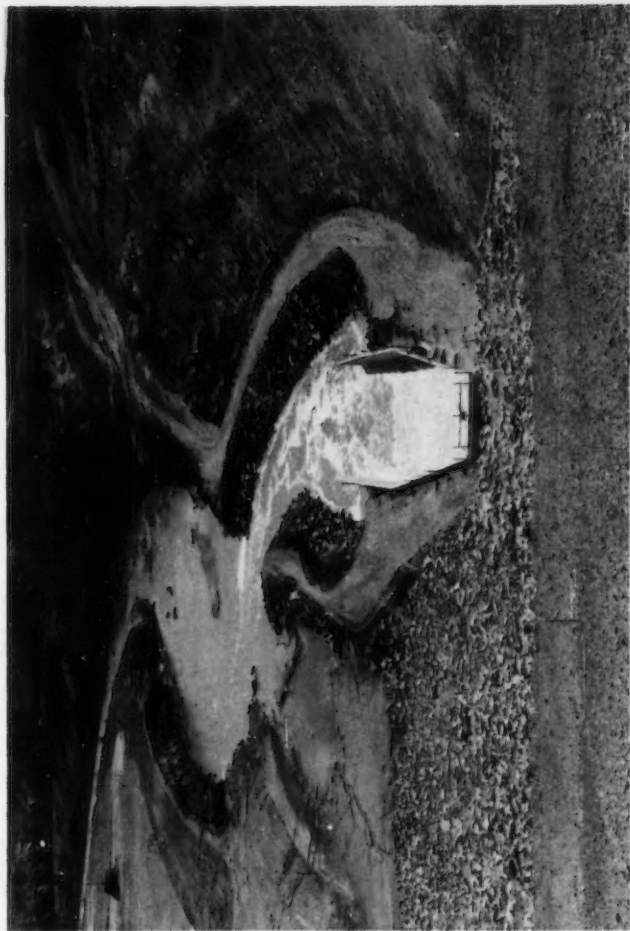
Fig. 34

Over-all view after flood had passed shows extent of downstream bank erosion on May 5, 1950. Note bars formed from eroded material. Compare with Figure 23.

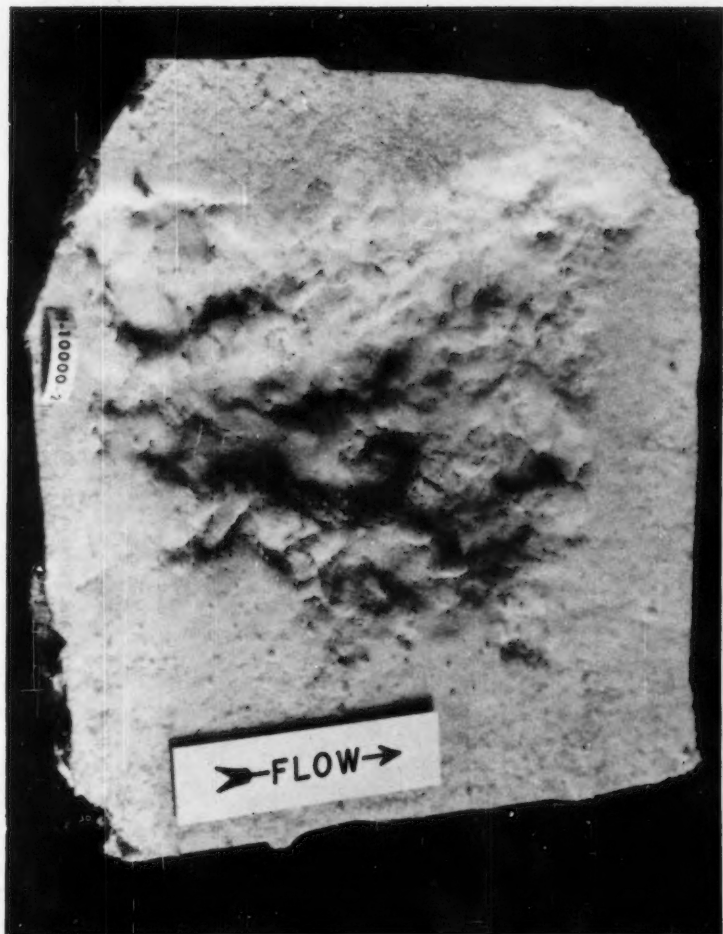
Fig. 35

The conduit inspection, in both instances, revealed that the concrete was in excellent condition with the exception of four small areas located in the 90° bend. Following the 1950 flood, plaster casts were made of the two most prominent areas. The largest area is about the size of a man's hand and by actual measurement has a maximum depth of erosion of 3/4 inch, Figure 35. The smaller area shows a maximum depth of 1/2 inch. The surface shown in Figure 35 was molded in sponge rubber against the plaster casts made in the field and are therefore an exact replica of the tunnel surface following the 1950 flood.

The eroded areas are located near the invert and near the bottom of the 90° bend. Construction timbers or ice falling into the shaft could have, by impact, caused the surface damage shown. Persons who have viewed the rubber casts have been of the unanimous opinion that the damage was not started by cavitation.

Following the 1951 flood, these areas were again noted. "There did not appear to have been any marked change in these areas as a result of the 1951 spring floods." "No repairs were believed necessary."

One of the four eroded areas found in 90° bend after the 1950 flood had passed. This area, shown full size, has the deepest erosion, 3/4 inch.
